Manhole Inspection Summary

Manhole # S19C1_008MH

Insp Date: **11/17/08 10:29 AM**

Location Address: **2126 PARKSLEY AV**

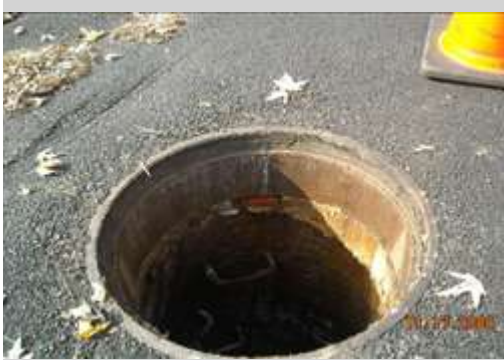
MISC.

☐ Prev. Rehab Weather: **Dry** Subject To Ponding: **Sheeting**

INFLOW EVIDENCE FROM SHEETING

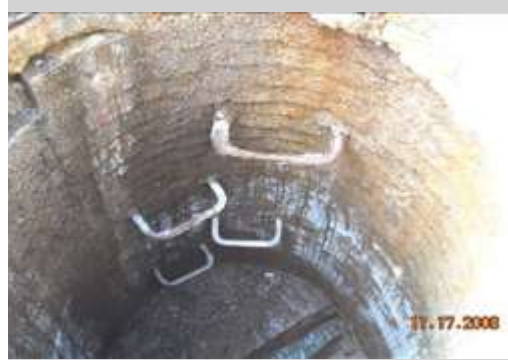
Defect 2

Steps Count: **4** Missing: **0** ☒ Corroded

CORRODED STEP

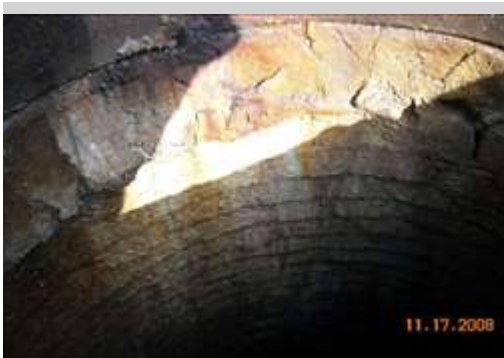
Defect 1

Infiltration: ☐ None ☒ Joint ☐ Cracks ☐ Mortar ☐ Roots ☐ Wall

INFILTRATION @ CHIMNEY/FRAME JOINT

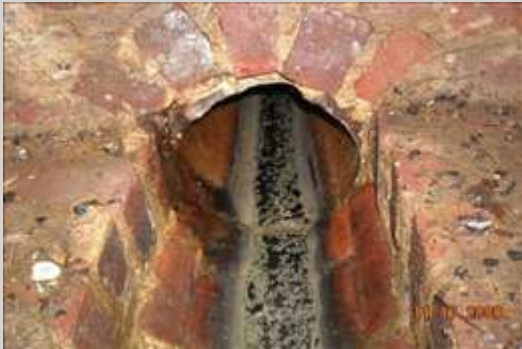
12 O'Clock Outflow

8 in. Circular Gravity Sewer
Pipe Out @ 12 O'Clock

Pipe Height: **8.4** (in.) Rod and Bar (Angled)
Pipe Material: **Clay** ☐ Pipe Lined
Invert Depth: **8.42** (ft.) Flow Characteristics: **Slow**
Deposits: ☒ None ☐ Mud ☐ Sludge ☐ Debris ☐ Grease
Silt Depth: **0** (in.) Deposits Extent:
Infiltration: **Weeper** Pipe Seal Cond: **Cracked**

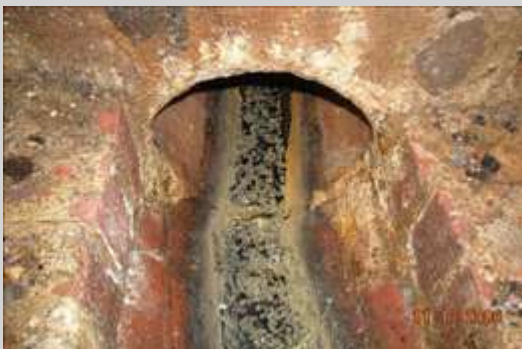
6 O'Clock Inflow

8 in. Circular Gravity Sewer
Pipe In @ 6 O'Clock

Pipe Height: **8.4** (in.) Rod and Bar (Angled)
Pipe Material: **Clay** ☐ Pipe Lined
Invert Depth: **8.25** (ft.) Flow Characteristics: **Slow**
Deposits: ☒ None ☐ Mud ☐ Sludge ☐ Debris ☐ Grease
Silt Depth: **0** (in.) Deposits Extent:
Infiltration: **None** Pipe Seal Cond: **Sound**
